SCP CARLSTADT PRINCIPAL
RESPONSIBLE
PARTY CLEANUP SUMMARY REPORT

Prepared By:
Jeffrey Simonsen, PM
Phillip Hunt, QC
Region II Technical Assistance Team
Weston/SPER
Edison, New Jersey 08837

Date Issued: November 7, 1986
Revised: January 14, 1987

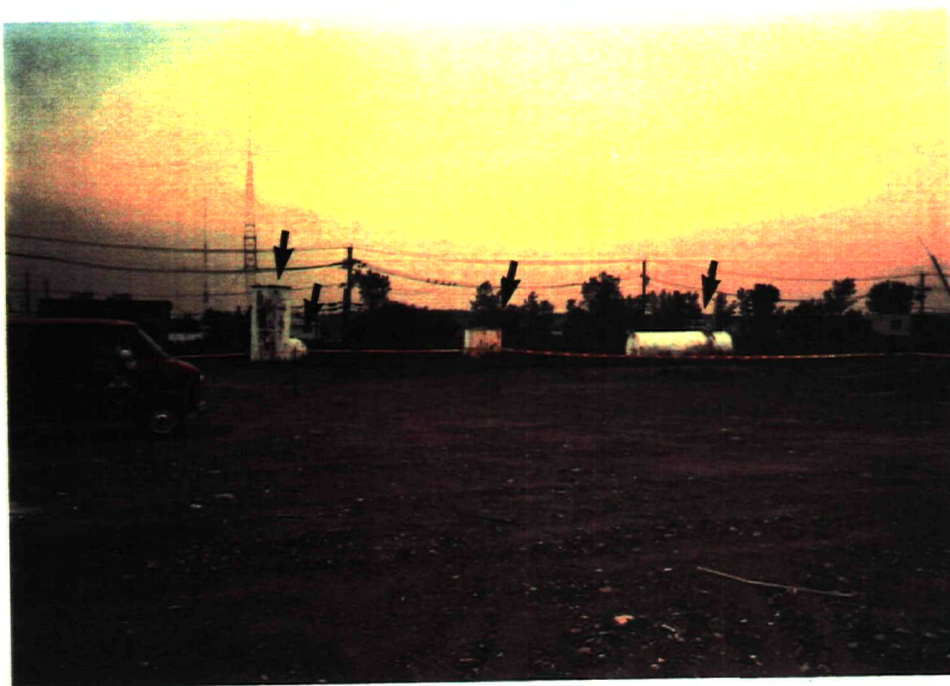
PHOTO # 1: Carlstadt site, looking to the northwest. From left to right are tanks T-4, T-5, T-8, and T-15.

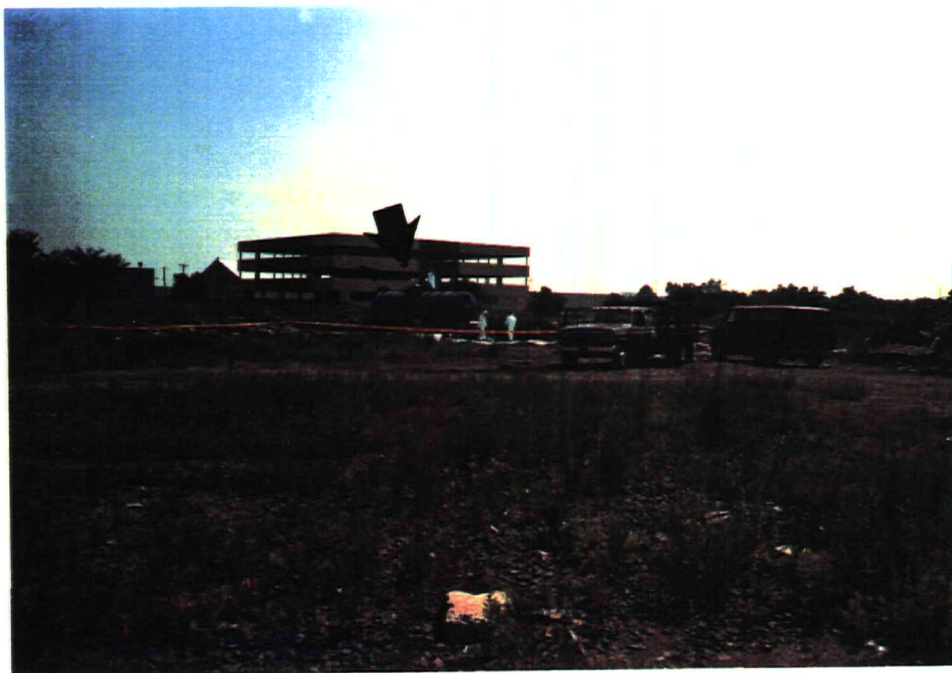
PHOTO # 2: Tank T-56, view is to the northeast.

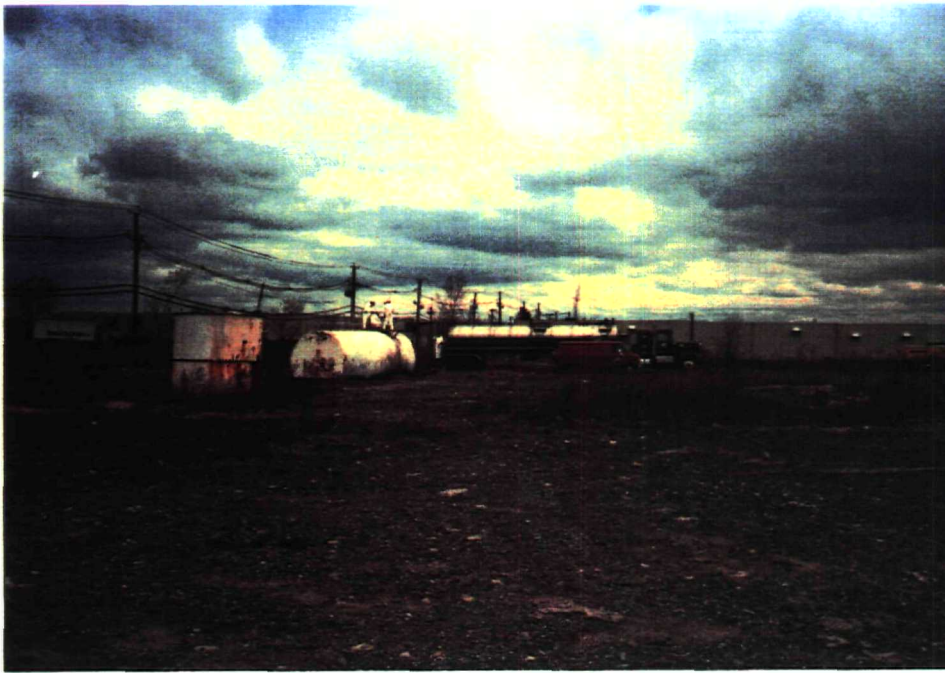
PHOTO # 3: Offloading of liquids from T-15 by vac-truck

Liquids were first removed at the very start of operations (Photo 3) because the accumulated rainwater had effectively created a "water blanket" on top of the sludges. This "water blanket" had to be removed before the sludges could be accessed. Disposal of liquids was essentially an on-going process, because water continued to accumulate from rainfall, and regular periods of decontamination. To handle this accumulation, T-4, after it had been emptied of its sludge, was used as a storage container until near the end of operations. Then T-4 was off loaded, decontaminated, and removed. The stored liquids were then sent to Chicago for incineration.

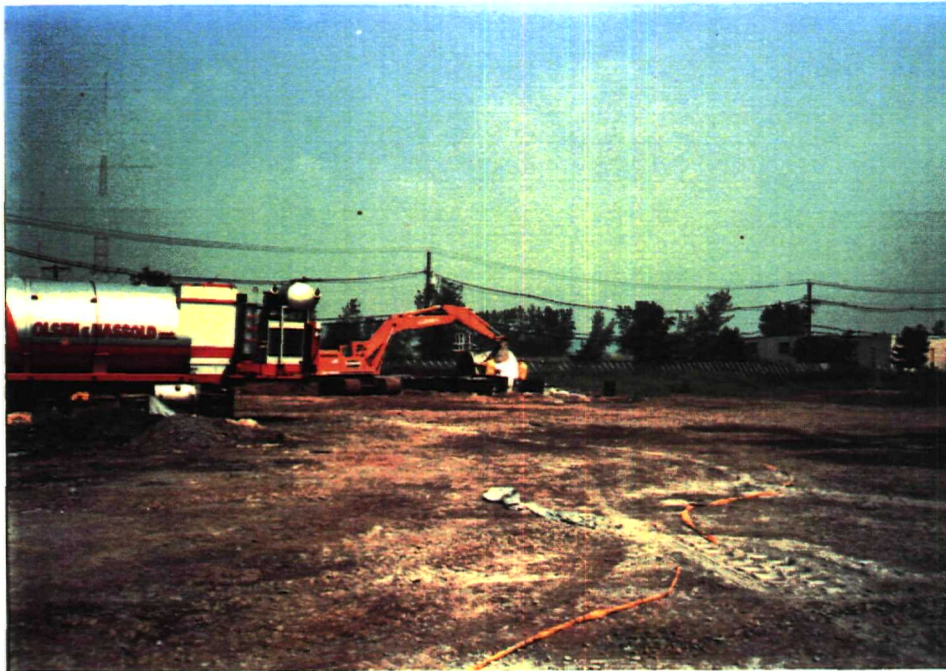
PHOTO # 4: T-15 sludge being removed by back-hoe.
Note the hopper just below the back-hoe bucket.

First, the sludges were pumped onto a vac-truck, and then off-loaded from the vac-truck into 55-gallon steel drums. As operations progressed, the sludge of T-15 proved to be too viscous for pumping. As a result, the top of T-15 was removed and the sludge was scooped out with a backhoe (Photo 4). The sludge was then poured into the drums through a hopper constructed of plywood, which was used in order to minimize spillage.

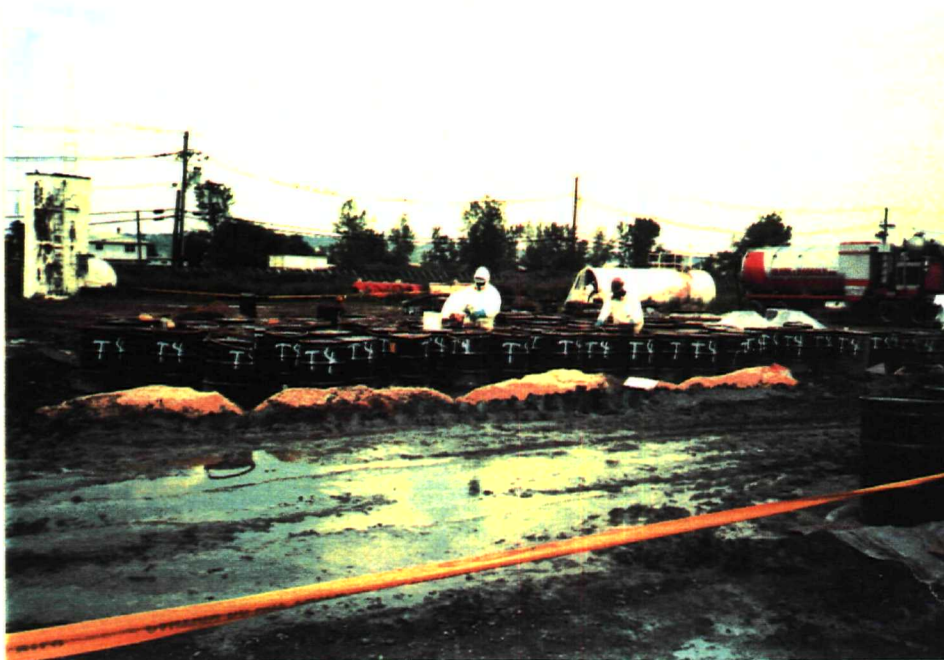
PHOTO # 5: Workers inspecting T-4 drums for stabilization.

After all of the drums were partially filled with sludge, kiln dust was added to induce stabilization. The mixture was then allowed to stand, and was periodically inspected for free liquids: if free liquids were discovered, additional kiln dust was added until stabilization was achieved (Photo 4). When all of the drums were believed by CWM personnel to be stable, they were shipped for disposal to the CWM landfill facility at Emelle, Alabama. Total drum count was 344.

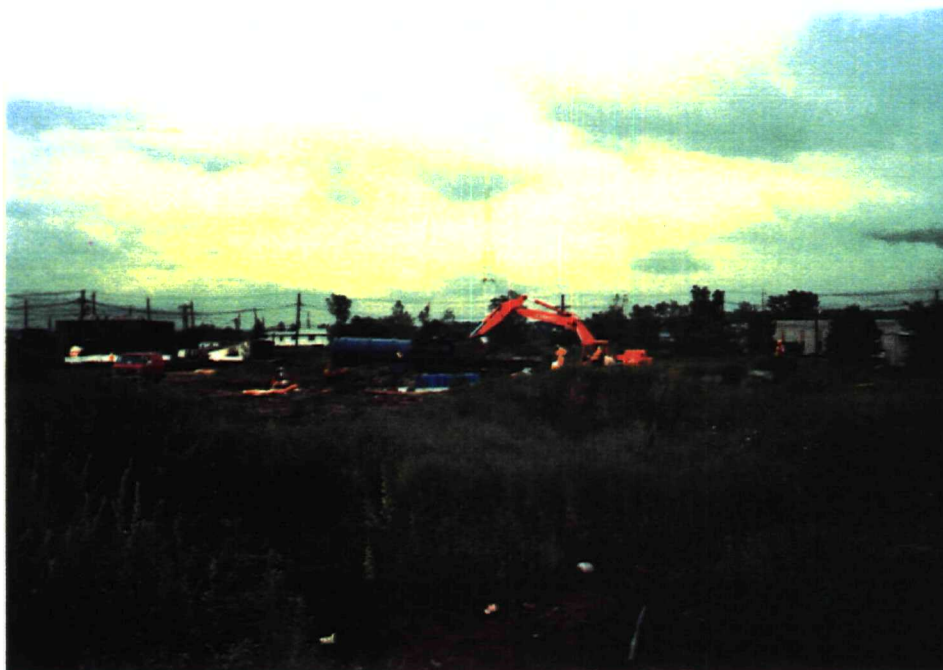
PHOTO # 6: Tank T-56 sludge being removed by back-hoe.

Sludges from T-56 were removed by scooping the sludge out with a backhoe, after a portion of tank's top had been removed (see Photo 6), and loading the sludge into a plywood sluiceway which had been constructed for the site. At this point, sawdust was mixed in to stabilize the sludge, and improve its ability to incinerate. The subsequent mixture was then loaded into a total of 92 thirty gallon plastic drums, which were shipped for disposal.

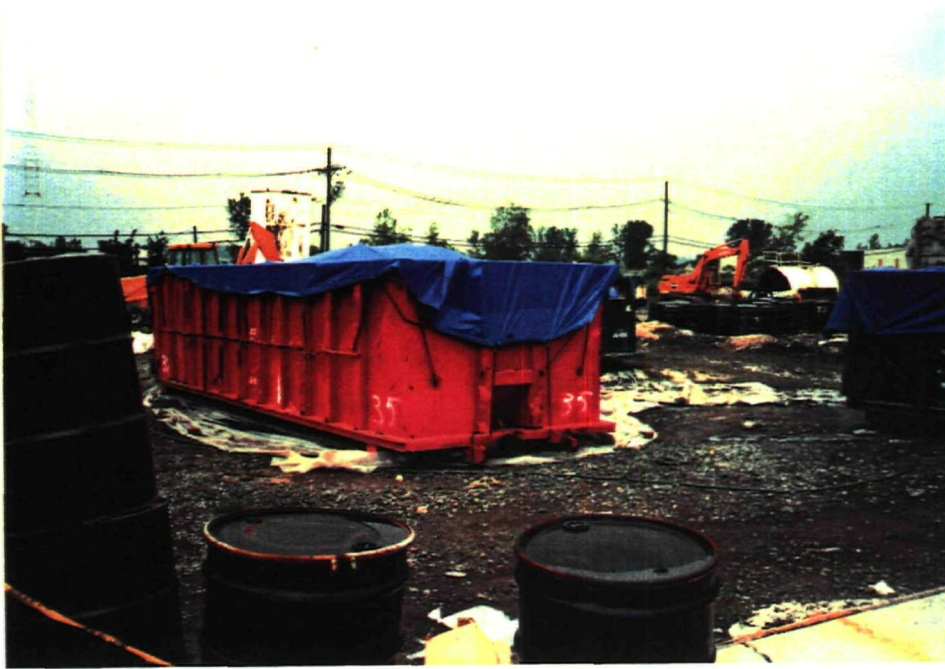
PHOTO # 7: One of the covered roll-offs used for storage of low level solid wastes.

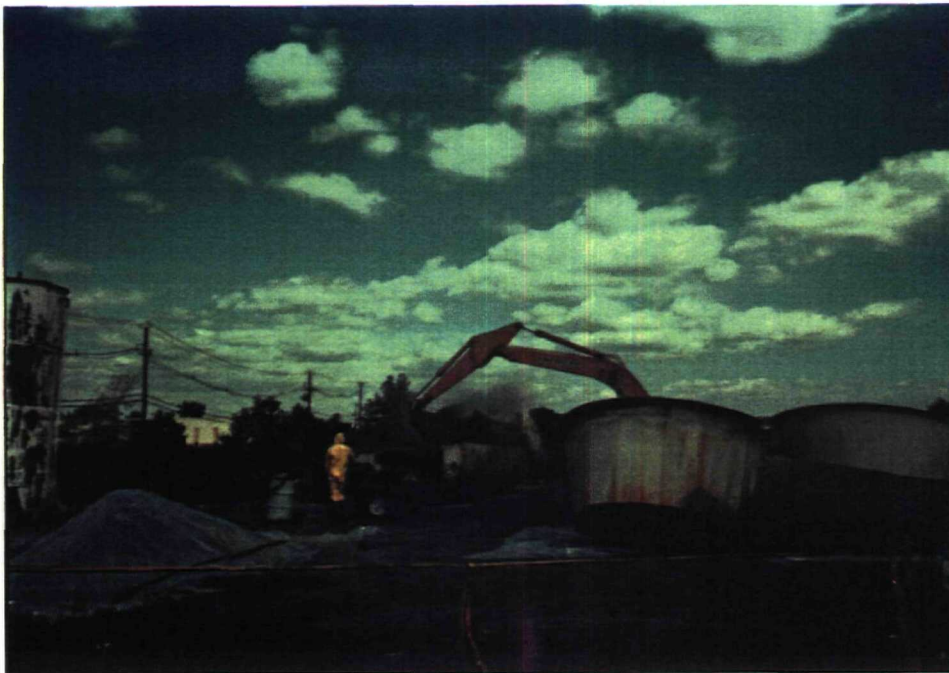
PHOTO # 8: Decontamination of tank parts, using T-15 as a catch basin. Note previously decontaminated tank parts resting on plastic in foreground.

All tanks were hand scraped and washed down with a solution of penetone and water which was run through a high pressure nozzle, commercially known as a "blaster". In order to control the accumulation of used wash solution, washing was done within the tank whenever possible, with the accumulated solution later being pumped out into a tanker. Some of the relatively smaller pieces were washed down after having been placed in T-15, which acted as a catch basin. These pieces were then placed on plastic sheeting and allowed to dry (Photo 8).

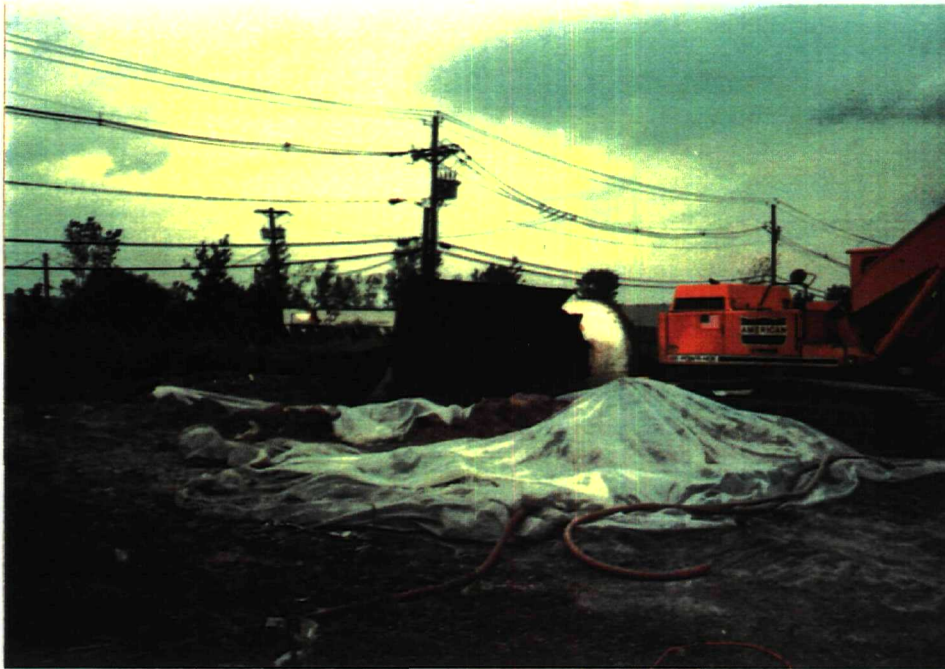
PHOTO # 9: Tank T-4 after decontamination, showing typical effectiveness of decontamination procedure. After this, cutting of the tank continued.

Next, all of the tanks were visually inspected, and wipe samples for PCB's were taken. Usually, the wipe samples were taken over several parts of the tank, and in some cases, were deliberately biased so that the "least clean" area was sampled (all of the tanks visually appeared quite clean). All of the wipe sample results were found to be "none-detected" for PCB's.

At this point, all of the tanks were considered by the OSC to be clean and suitable for removal. The tanks were then cut up using a welding torch and removed by a scrap metal dealer (Photos 9 and 10).

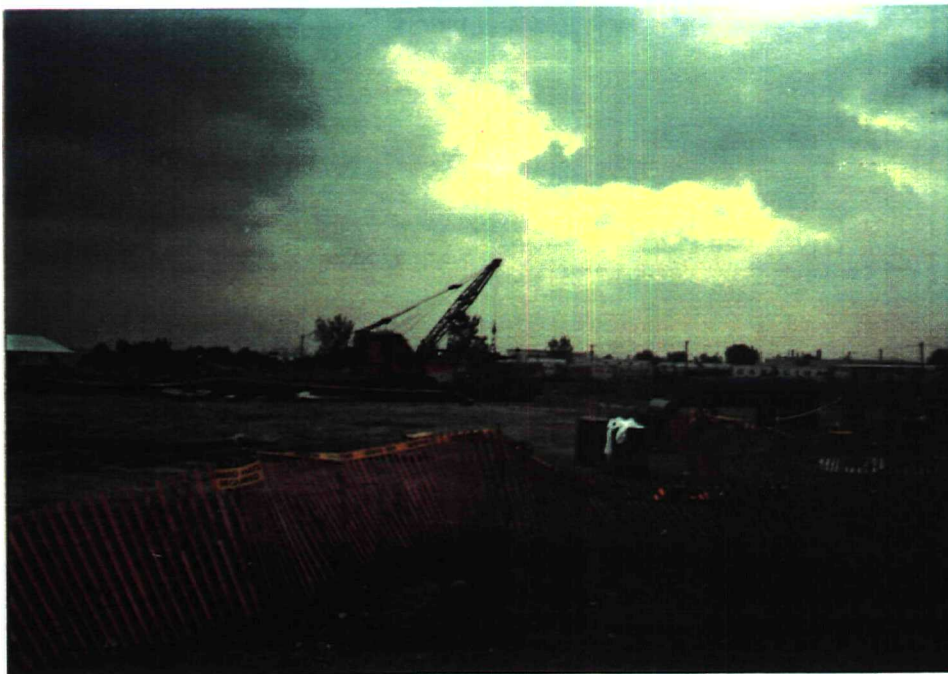
PHOTO # 10: Tank parts being loaded by scrap dealer for removal.

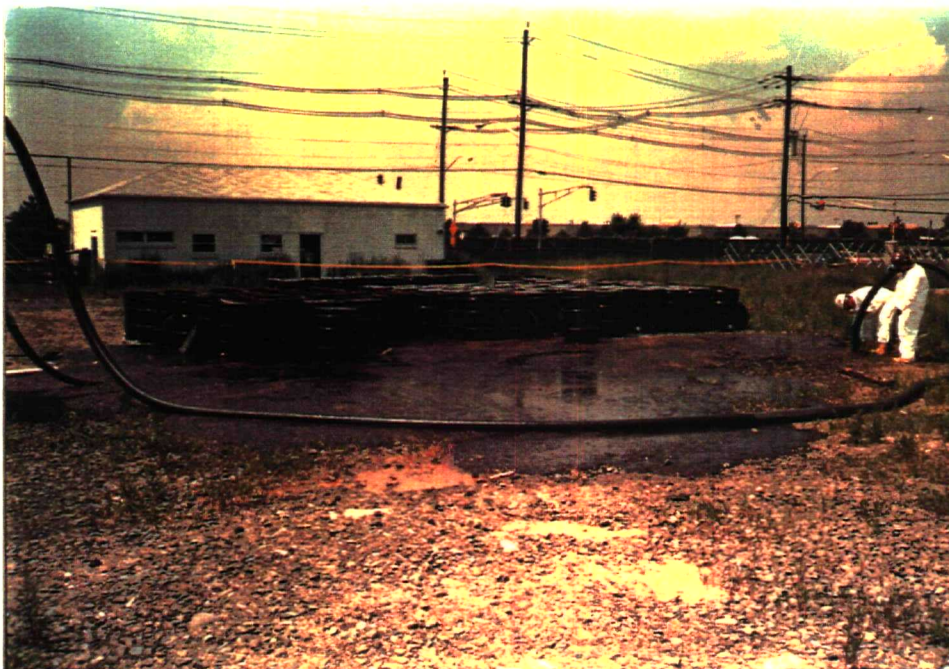
Two spills of material associated with this site occurred during site operations. The first occurred on site when the back of a vacuum truck used for off loading the tanks was inadvertently opened by a worker: an estimated 3,000 gallons of material was spilled (Photos 11 and 12). All of the material was immediately vacuumed up and was later disposed of along with the rest of the sludges from the tanks from which they came (T-4 and T-15).

PHOTO # 11: Spill which resulted when back of vac-truck was accidentally opened by worker. Vacuuming of spill is in progress.

Soil contaminated by this spill was scraped up and stored in covered roll-offs until disposal could be arranged. Sample analysis by CWM showed PCB and flash point levels were low enough that the soil could be landfilled, and it was later removed to the CWM landfill at Model City, New York.

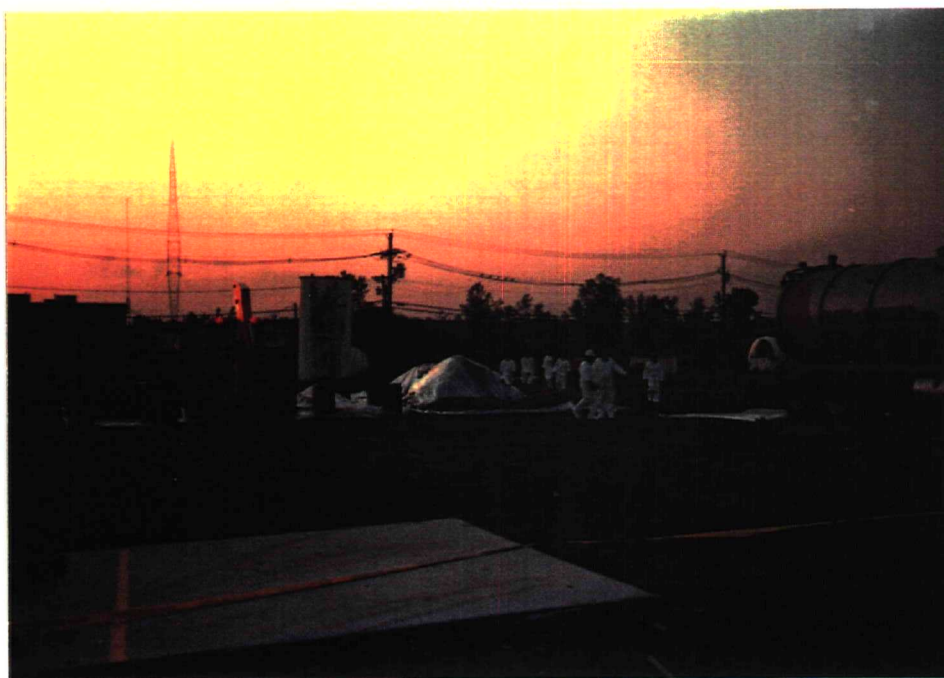
PHOTO # 12: Background: soil contaminated from above spill being stored on, and under, plastic sheeting. Construction of berm in progress. This soil was later transferred to roll-offs (see photo 7). Foreground: decontamination pad.

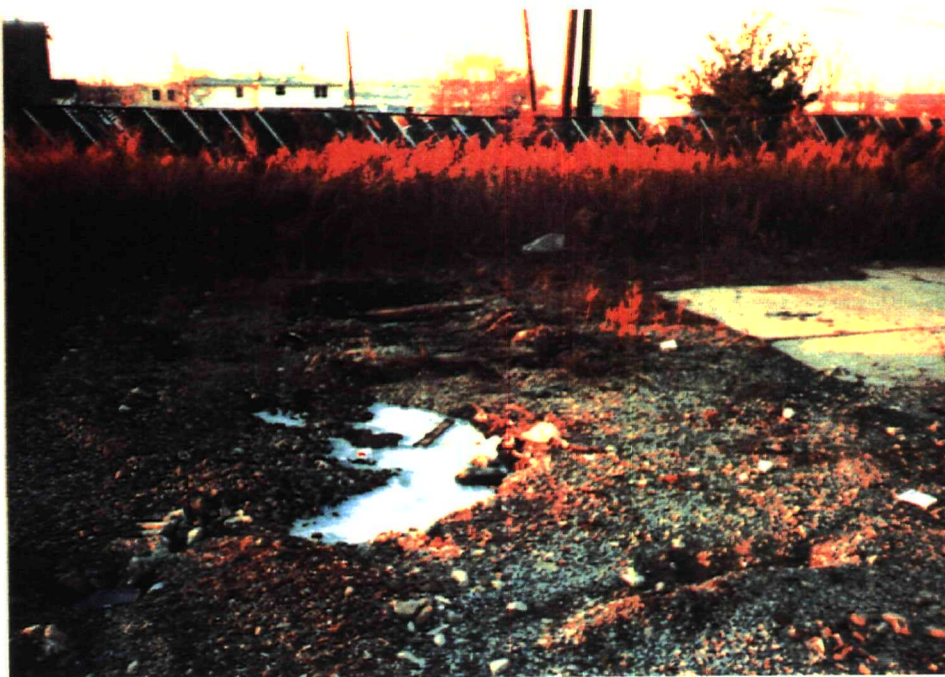
APPENDIX 5, PHOTO 1: Site formerly occupied by T-5. View is toward the northwest, Gotham Parkway is in the background, behind fence.

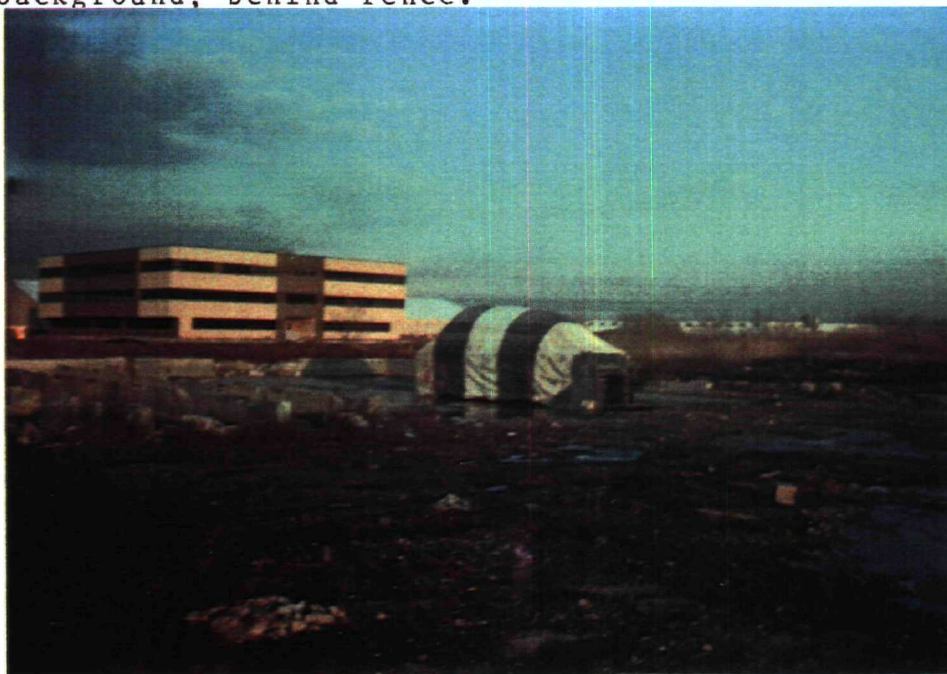
APPENDIX 5, PHOTO 2: T-5 at its new location: the concrete pad formerly occupied by T-56 (compare with photo 2 of main text). View is to the northeast.

Because the presence of T-5 was delaying the start of the remedial investigation, and because T-5 was leaking, Inmar was instructed to re-package the sludge in a safe container until a disposal method could be decided upon. This, however, was not done until December 15, 1986, the final deadline given to Inmar in a December 4 letter from the EPA Office of Regional Counsel. On that day, a TAT member visited the site and found the tank to have been placed in a roll-off, which had been lined with plastic, and covered with a heavy-duty tarp. The roll-off/T-5 combination had been placed on the concrete pad formerly occupied by Tank T-56. The OSC subsequently visited the site, and determined that this arrangement would be satisfactory.

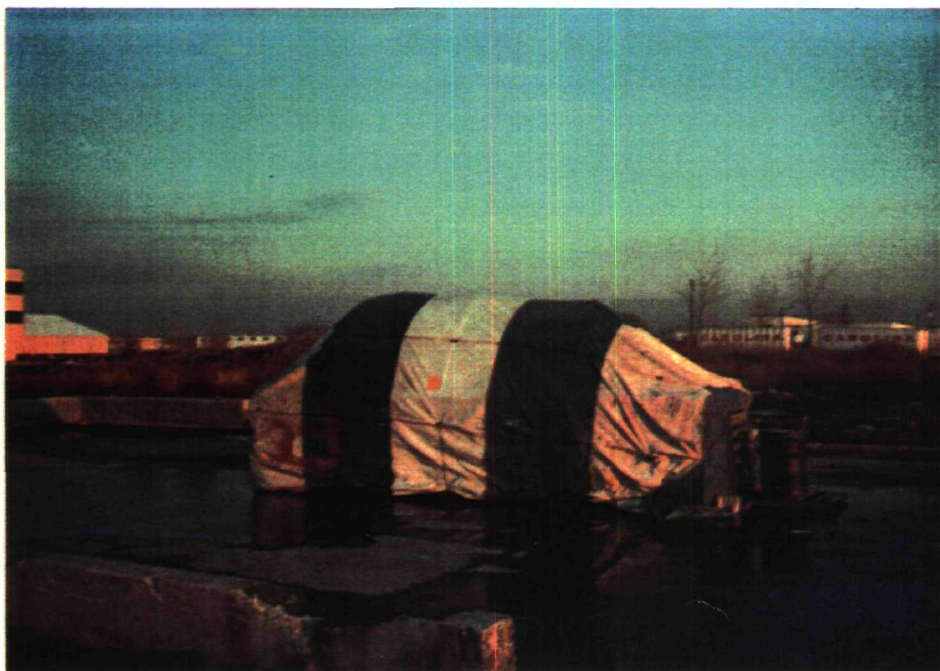
APPENDIX 5, PHOTO 3: T-5/roll-off combination on concrete pad. Outline of roll-off visible under tarp. View is to southeast.

At this time, the tank is being stored in a roll-off, which has been lined with plastic sheeting, and covered with a heavy-duty tarp. The tarp is held securely in place by a series of black rubber shock cords. PCB warning stickers have been affixed to the tarp and are readily visible. Additionally, the tank/roll-off combination has been moved onto the cement pad formerly occupied by T-56. Tank T-5 was stored in this fashion on December 15, 1986, after EPA demanded that the tank be stored in a more secure manner. Prior to that demand, the tank had remained in the same setting and condition that it had when operations began in April. For additional details on this situation see Appendix 5.

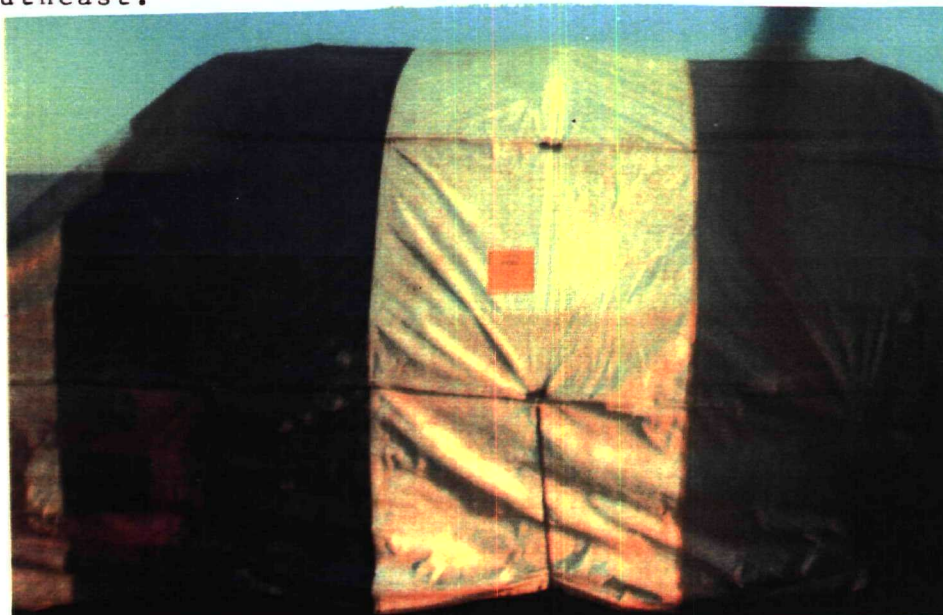
APPENDIX 5, PHOTO 4: Close up of T-5/roll-off combination. Note PCB warning label and outline of roll-off under tarp. View is to southeast.
